# **Pentium® Pro Processor Specification Update**

Release Date: January 1997

Order Number: 242689-024

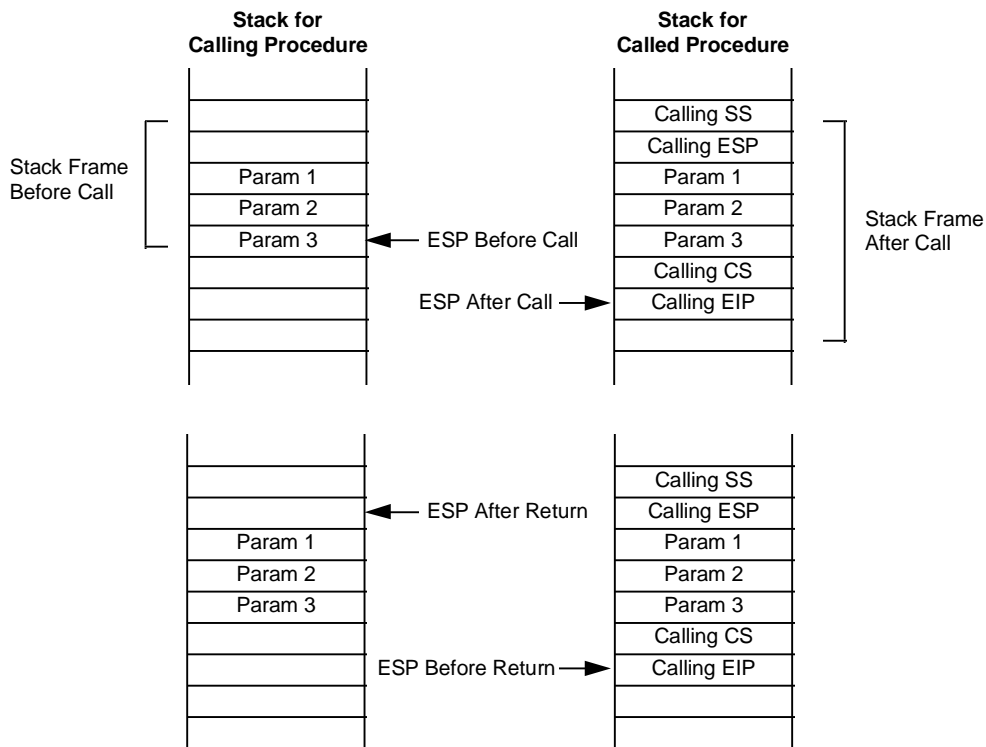
**Figure 4-3. Stack Switch on a Call to a Different Privilege Level**

Note: On a return, parameters are released on both stacks if the correct value is given for the *n* operand in the RET *n* instruction.

When making a call to a more privileged protection level, the processor does the following (see Figure 4-3):

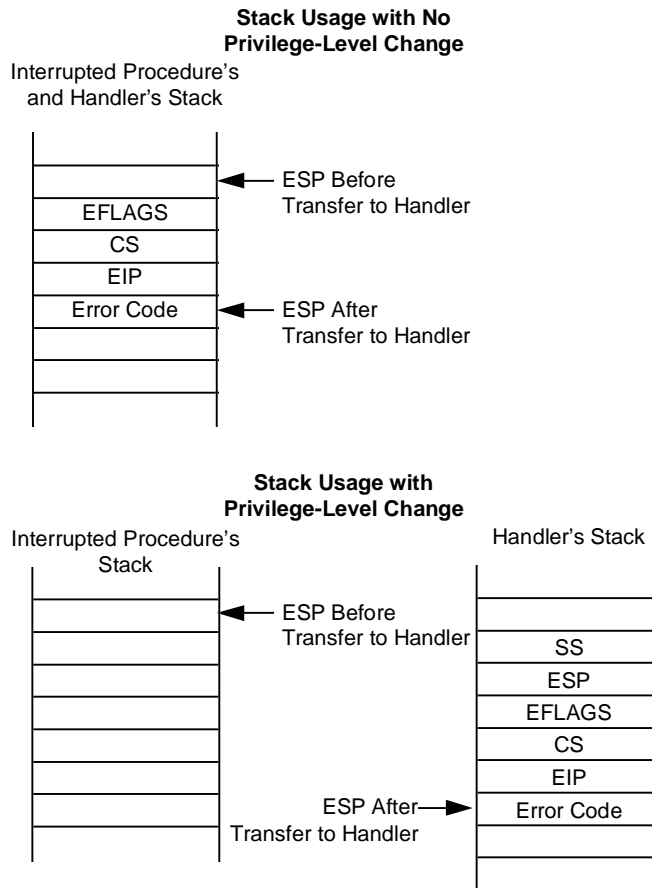
**Figure 4-4. Stack Usage on Transfers to Interrupt and Exception Handling Routines**

When executing a return from an interrupt or exception handler from a different privilege level than the interrupted procedure, the processor performs these actions:

1. Performs a privilege check.
2. Restores the CS and EIP registers to their values prior to the interrupt or exception.
3. Restores the EFLAGS register.
4. Restores the SS and ESP registers to their values prior to the interrupt or exception, resulting in a stack switch back to the stack of the interrupted procedure.
5. Resumes execution of the interrupted procedure.
